# Galveston Street Tree Survey—Addendum #1

Following publication of the *Hurricane Ike Street Tree Survey Report & Recommendations* for Galveston, Texas, the authors conducted additional analysis of the data recorded during the survey of April 21-22, 2009.

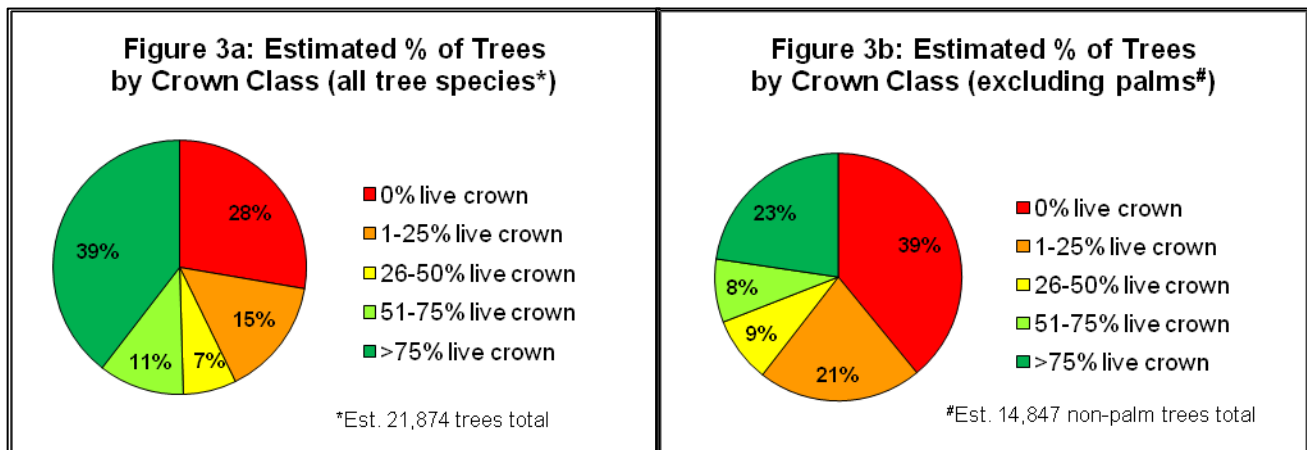
Figures 3a and 3b below show the percent of trees surveyed, by crown class, first including palm trees and then excluding palms. This gives a rough indication of how many right-of-way (ROW) trees may be dead (0% live crown), dying (1-25% live crown), doubtful (26-50% live crown), may recover (51-75% live crown), or are recovering (>75% live crown).

Out of all the trees surveyed, roughly one-half have less than 50% live crown cover and 28% of trees show no signs of life. When palms are excluded (since most palms appear to be recovering), the data is even more striking: an estimated 5,797 of these non-palm trees (39% of the 14,847 total) show no signs of life and 69% have less than 50% crown cover.

One positive note is that 23% of trees other than palms have good leaf canopy and appear to be recovering from the storm surge. However, summer heat or other climatic conditions like drought could have an impact on these categories. Trees near 50% live crown today could still succumb to additional stresses by the end of the summer.
